APPLICATION INVESTIGATION:

Project Description: Reflective Sign Coating
Customer: Transurban
Location: Melbourne
Date: May 2018
Product: X-Restore

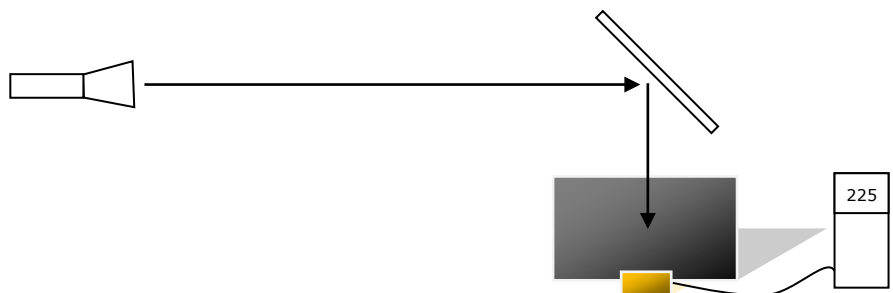
Test Method Prior to X-Restore being applied a test rig was set up to measure the light intensity of the light reflected off the sign at approximately 45 degrees angle to the surface of the sign.

Test Rig Configuration A focused light beam was reflected off the sign through a hole in the top of the box directly onto the light meter sensor and the reading recorded.

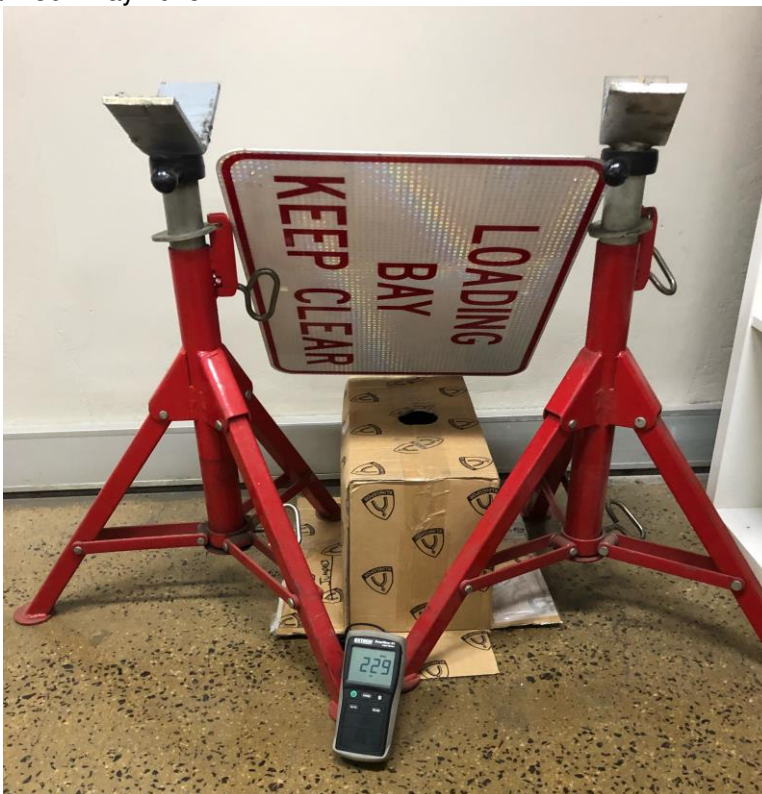
Test 1 - Uncoated @ 7:15am 30th May 2018

Test	Status	Light Level	Result	Comments
1	Prior to Coating	229 LUX	Reference	
2	3 Hrs after Coating	308 LUX	34.5% Increase	Surface good to touch, felt soft
3	23 hrs after Coating	330 LUX	44.1% Increase	Surface good to touch, felt hard

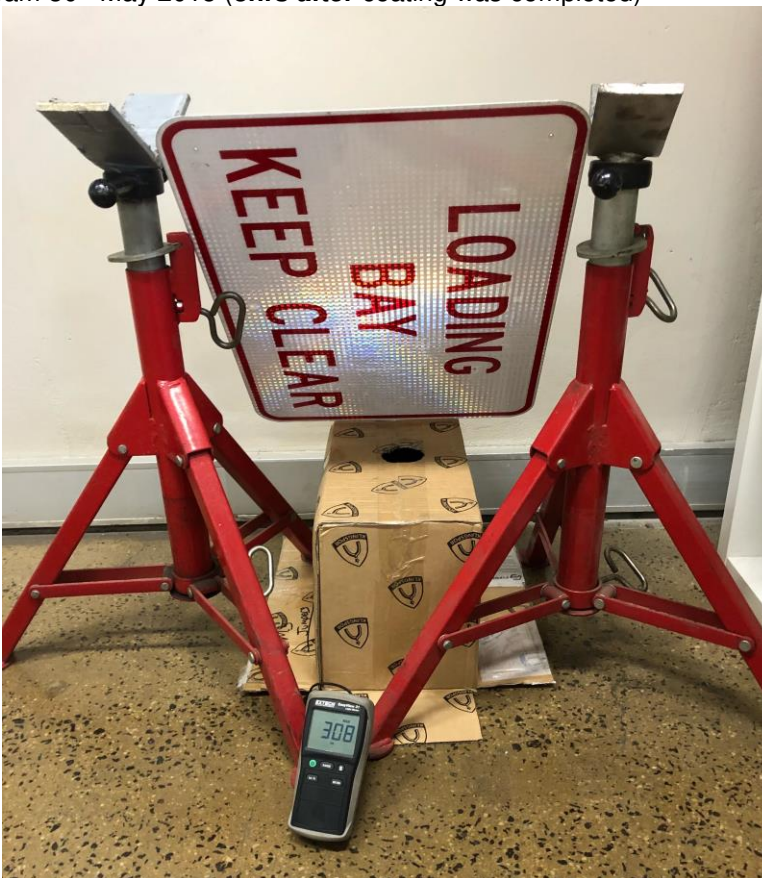
Test 2 – Coated @ 11:15am 30th May 2018 (3hrs after coating was completed)

You will note in test 2 and 3 the sign has a greater reflective intensity. The glow is the reflection of light from the tape on the cardboard box just from room lighting.

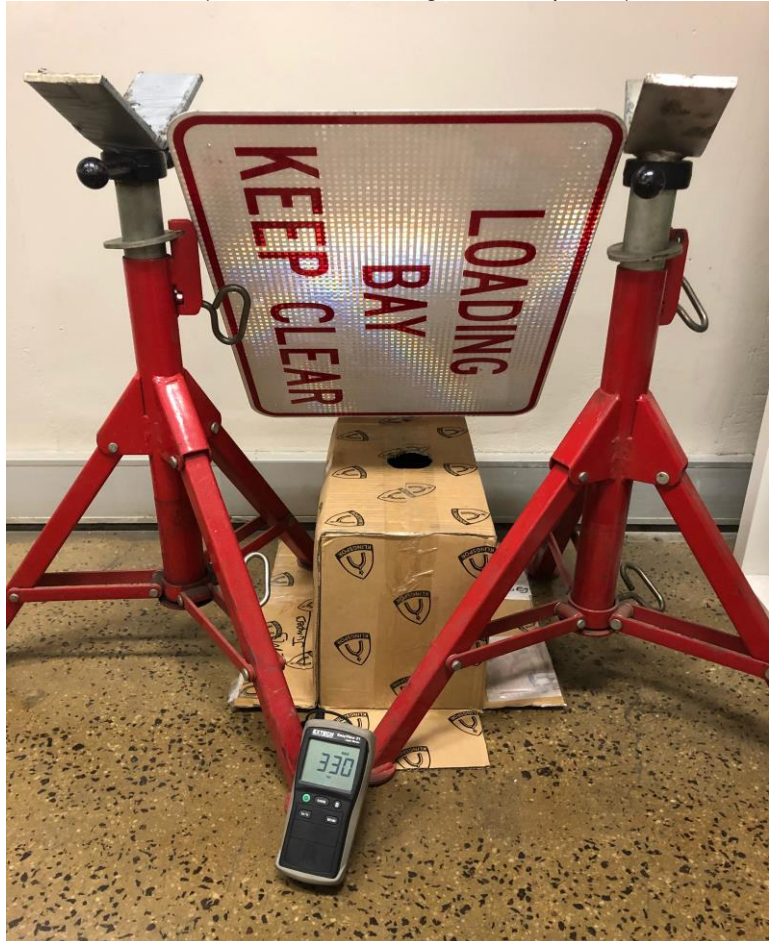
Test 3 – Coated @ 7:15am 1st June 2018 (23hrs after coating was completed)

Comments The initial expectation of the trial was a slight reduction in the reflectivity. What was experienced, was an un-expected gain of 44.1%. What we believe has occurred, is a more concentrated (less diffused) beam of light reflecting off the surface. All environmental conditions were maintained to ensure accurate correlation between the results could be established.
